# Manhole Inspection Summary

Manhole # S37QQ\_003MH

Insp Date: **1/17/07 8:20 AM**

**Location** Address: **2511 26TH ST**

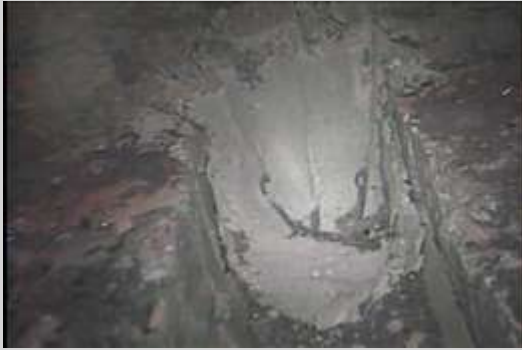
### Pipe In @ 7 O'Clock

Pipe Material: ☐ Pipe Lined  
Invert Depth: (ft.) Flow Characteristics: **None**  
Deposits: ☒ None ☐ **Mud** ☐ Sludge ☐ **Debris** ☐ Grease  
Silt Depth: (in.) Deposits Extent:  
Infiltration: **None** Pipe Seal Cond: **Unknown**
